Port of Portland

Date: September 23, 1994
To: George McShea
From: Bernie Butler *BMB*
Subject: AUDIT REPORT - WEST STATE INC.

APPENDIX A
SITE RECONNAISSANCE PHOTOGRAPHS

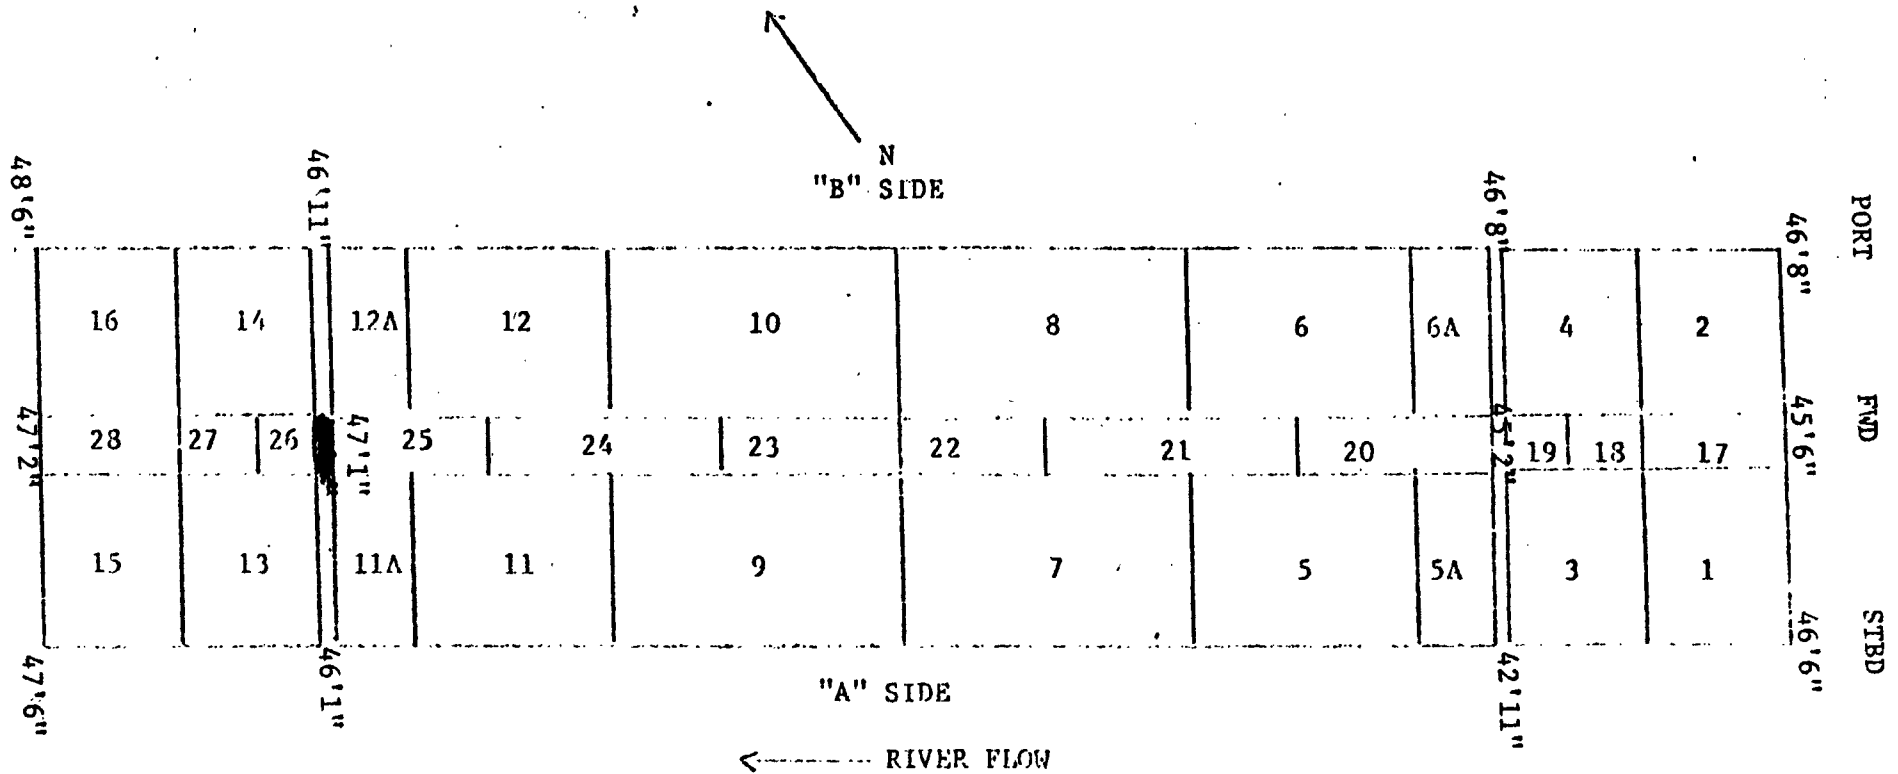
KEY PLAN SHOWING COMPARTMENT DESIGNATIONS FOR YFD-69

Basin soundings YFD-69, 3/28/77, 1030. River stage was 3'.
Reading adjusted to 0' river.

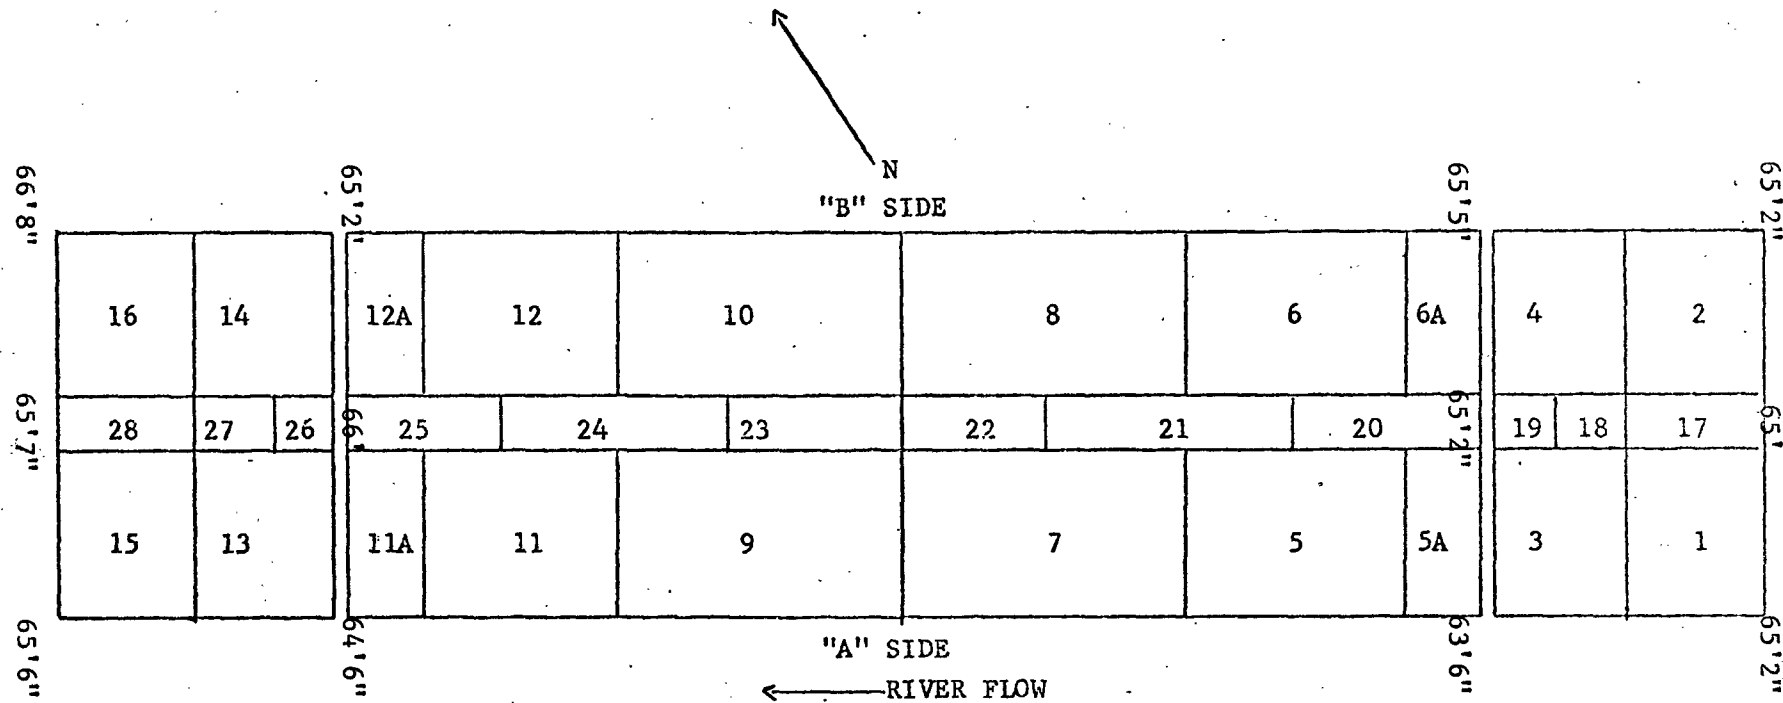
KEY PLAN SHOWING COMPARTMENT DESIGNATIONS FOR YFD-69

BASIN SOUNDINGS, MAY 11, 1971

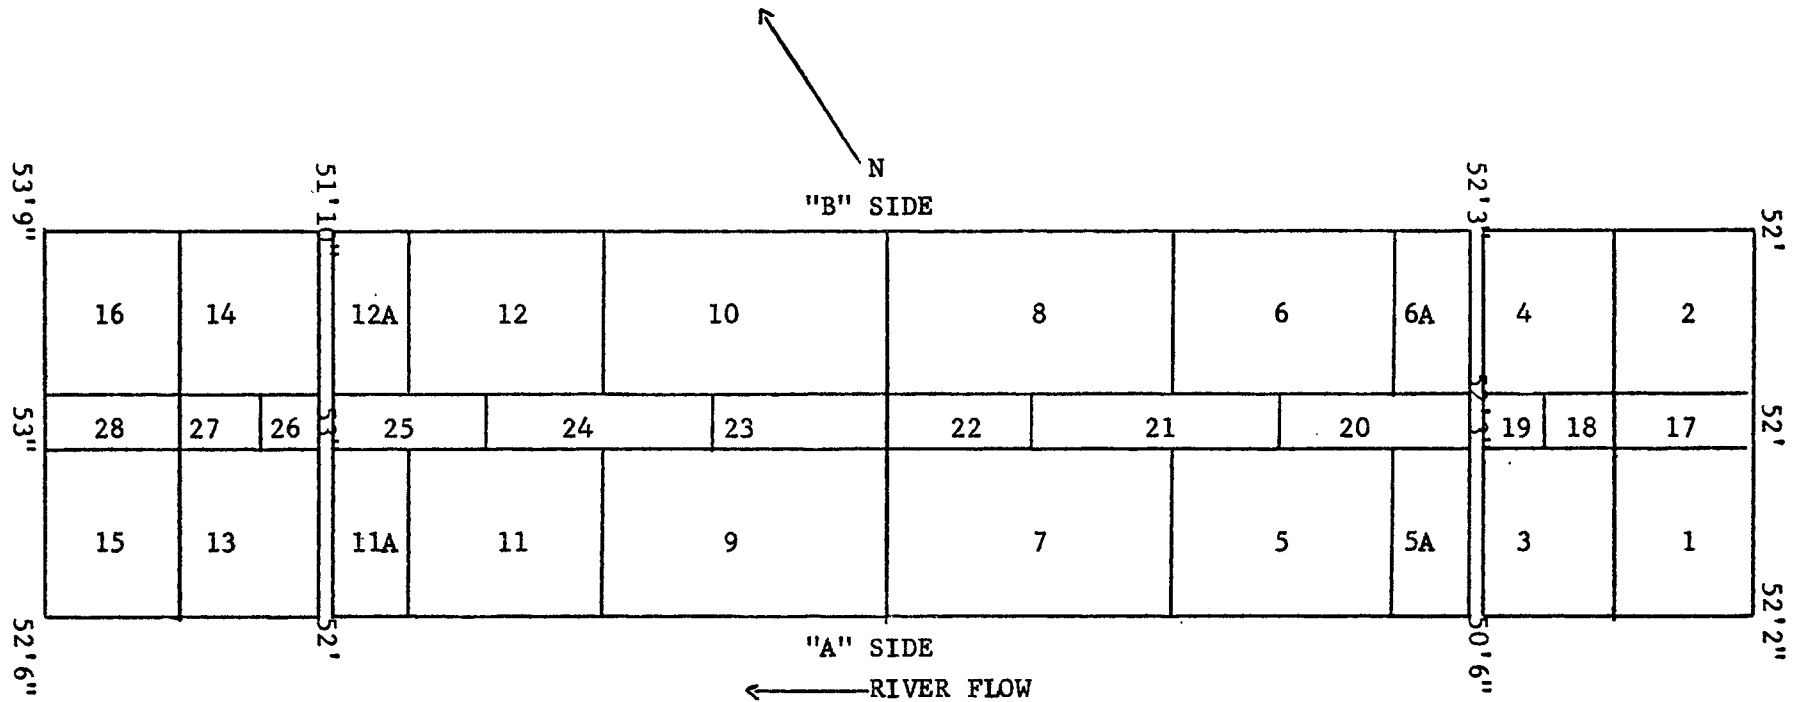
KEY PLAN SHOWING COMPARTMENT DESIGNATIONS FOR YFD-69

May 12, 1970
 Time: 1300
 Riverstage: 5'5"
 Basis soundings
AKM Dock Foreman

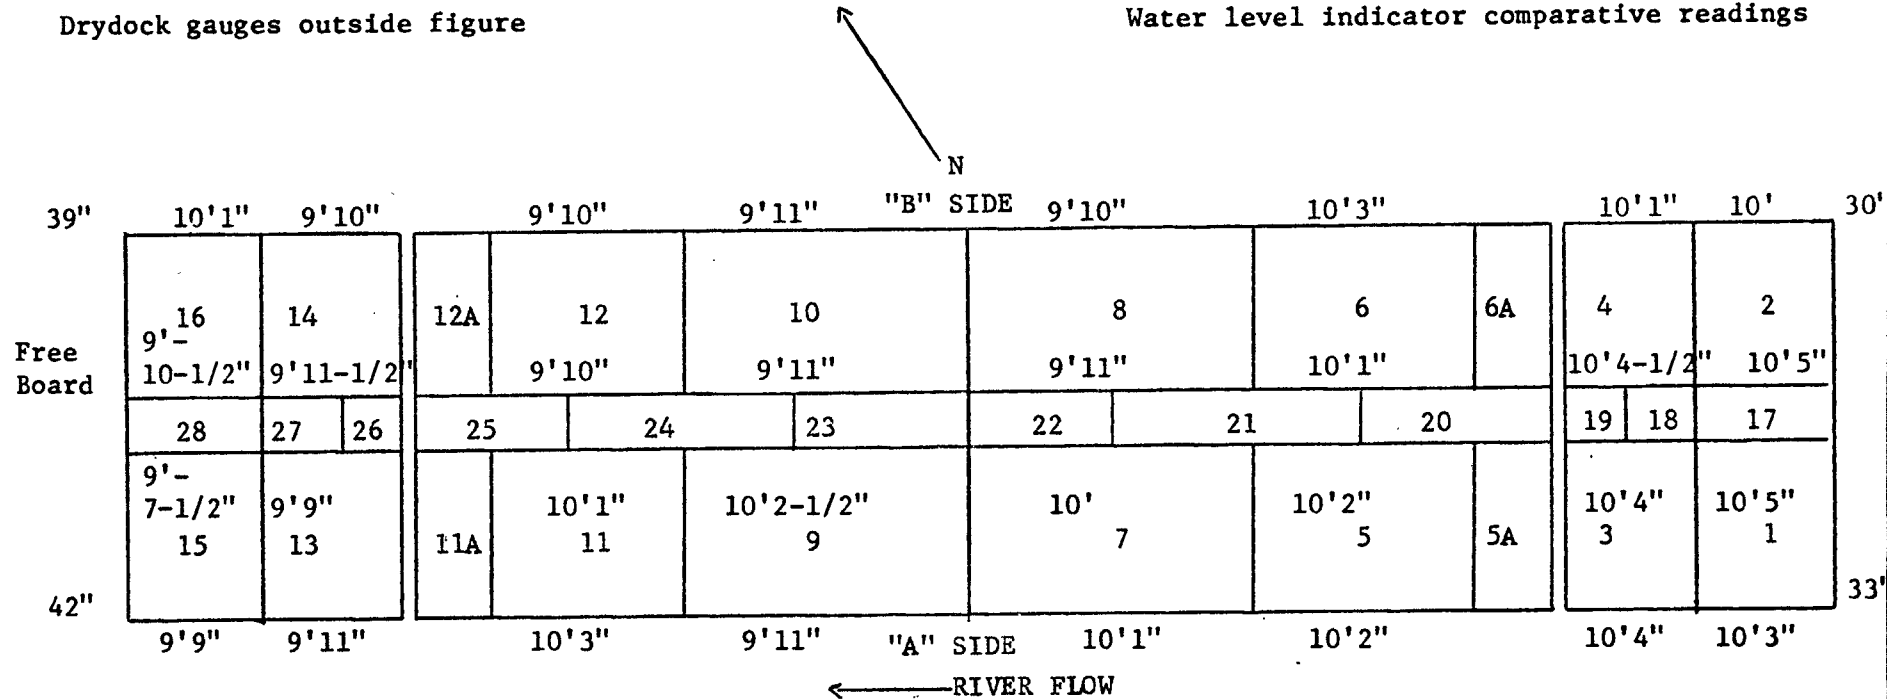
KEY PLAN SHOWING COMPARTMENT DESIGNATIONS FOR YFD-69

May 15, 1970 - Time 0900
 Sounding Navy Drydock YFD-69
 Flooding comp and dock free board.
 Dock Foreman: A. K. Murdock

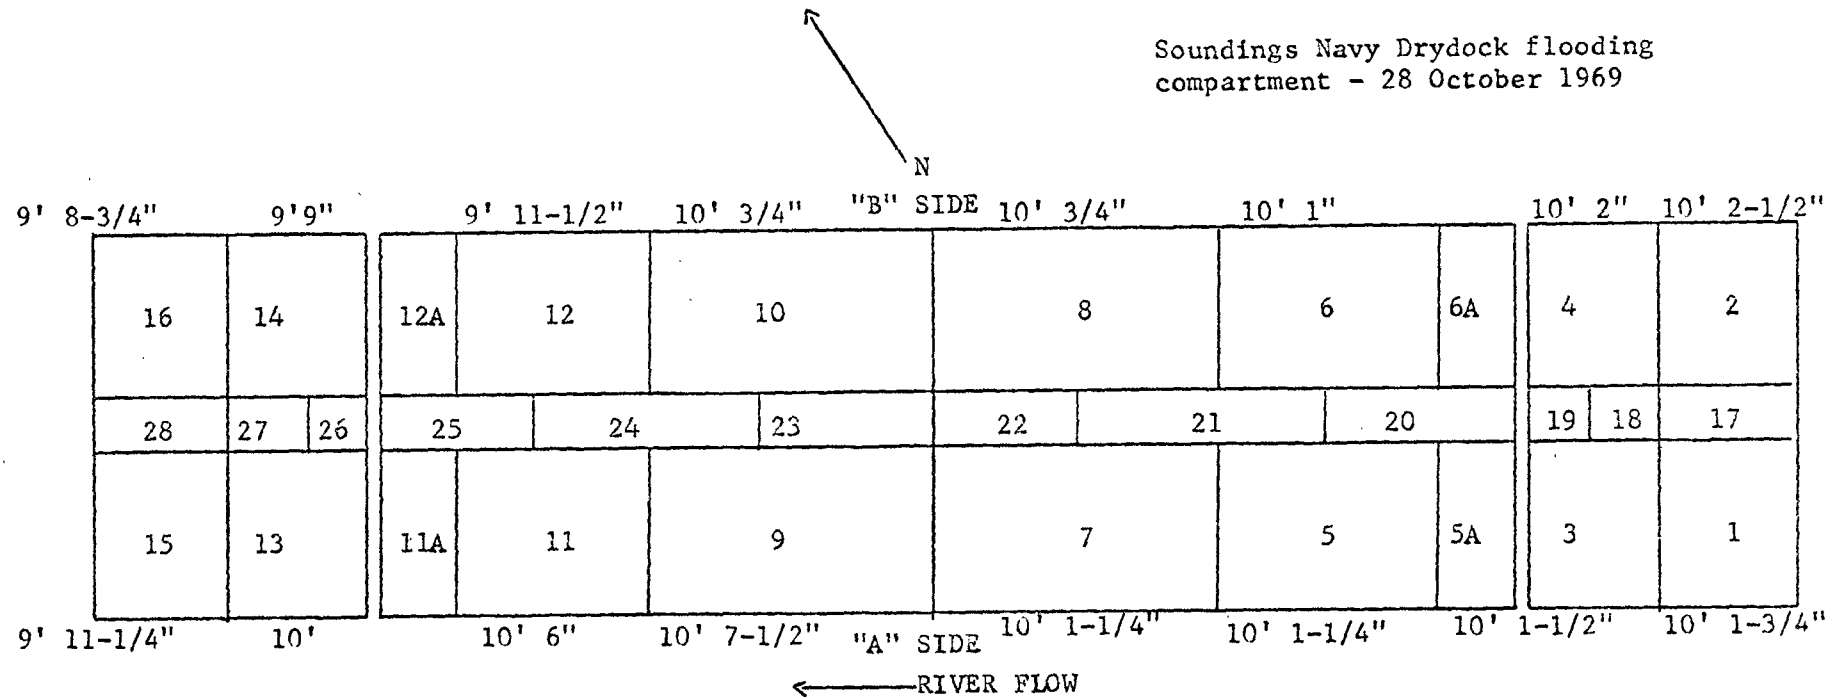
KEY PLAN SHOWING COMPARTMENT DESIGNATIONS FOR YFD-69

Soundings Navy Drydock flooding
compartment - 28 October 1969

All drydock gauges adjusted to within 2"

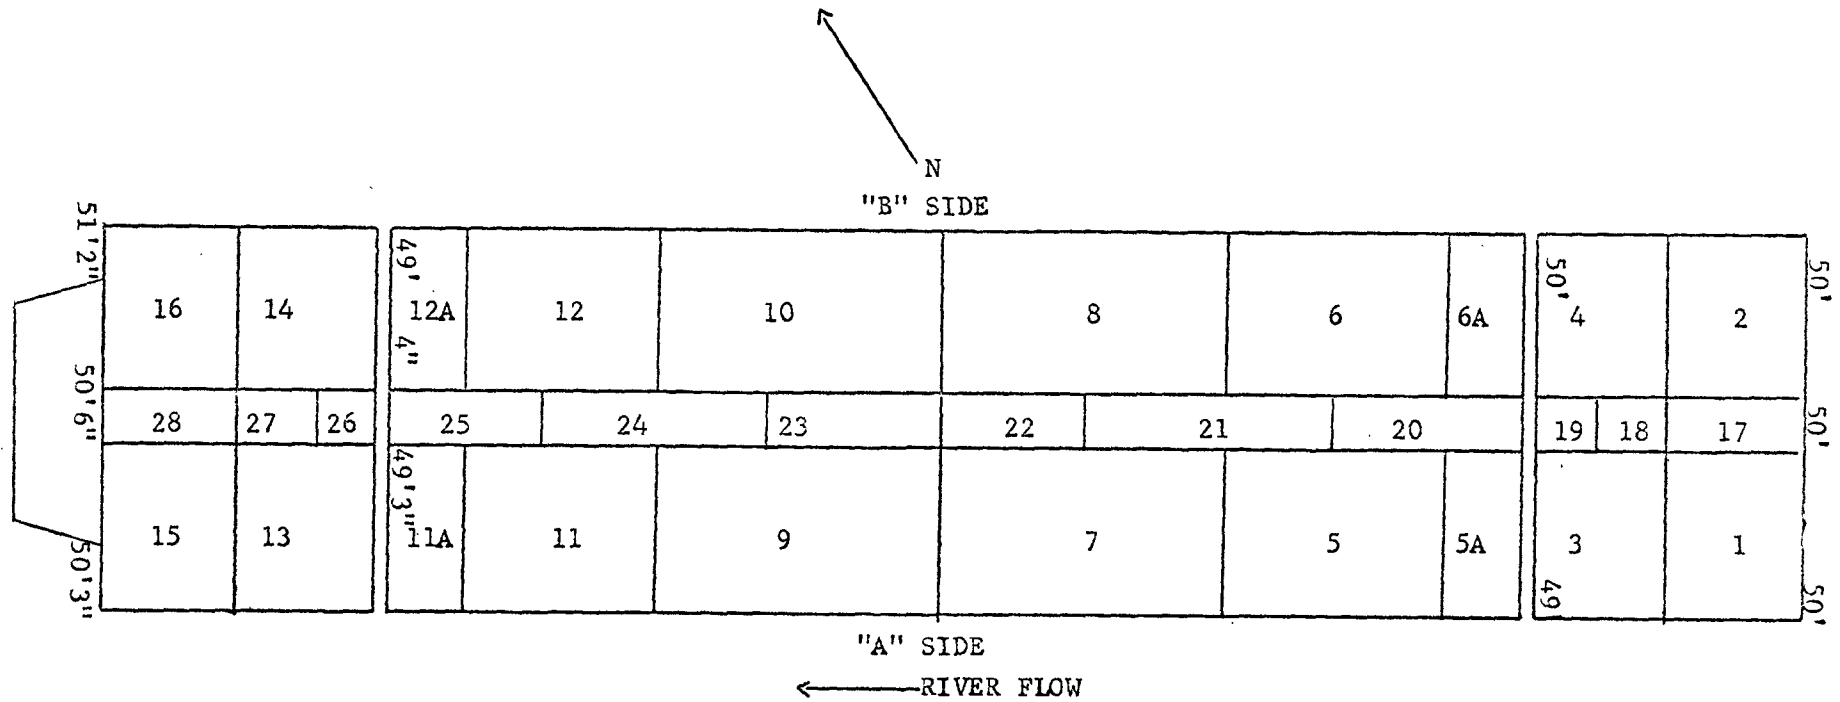
KEY PLAN SHOWING COMPARTMENT DESIGNATIONS FOR YFD-69

Basin soundings September 27, 1969

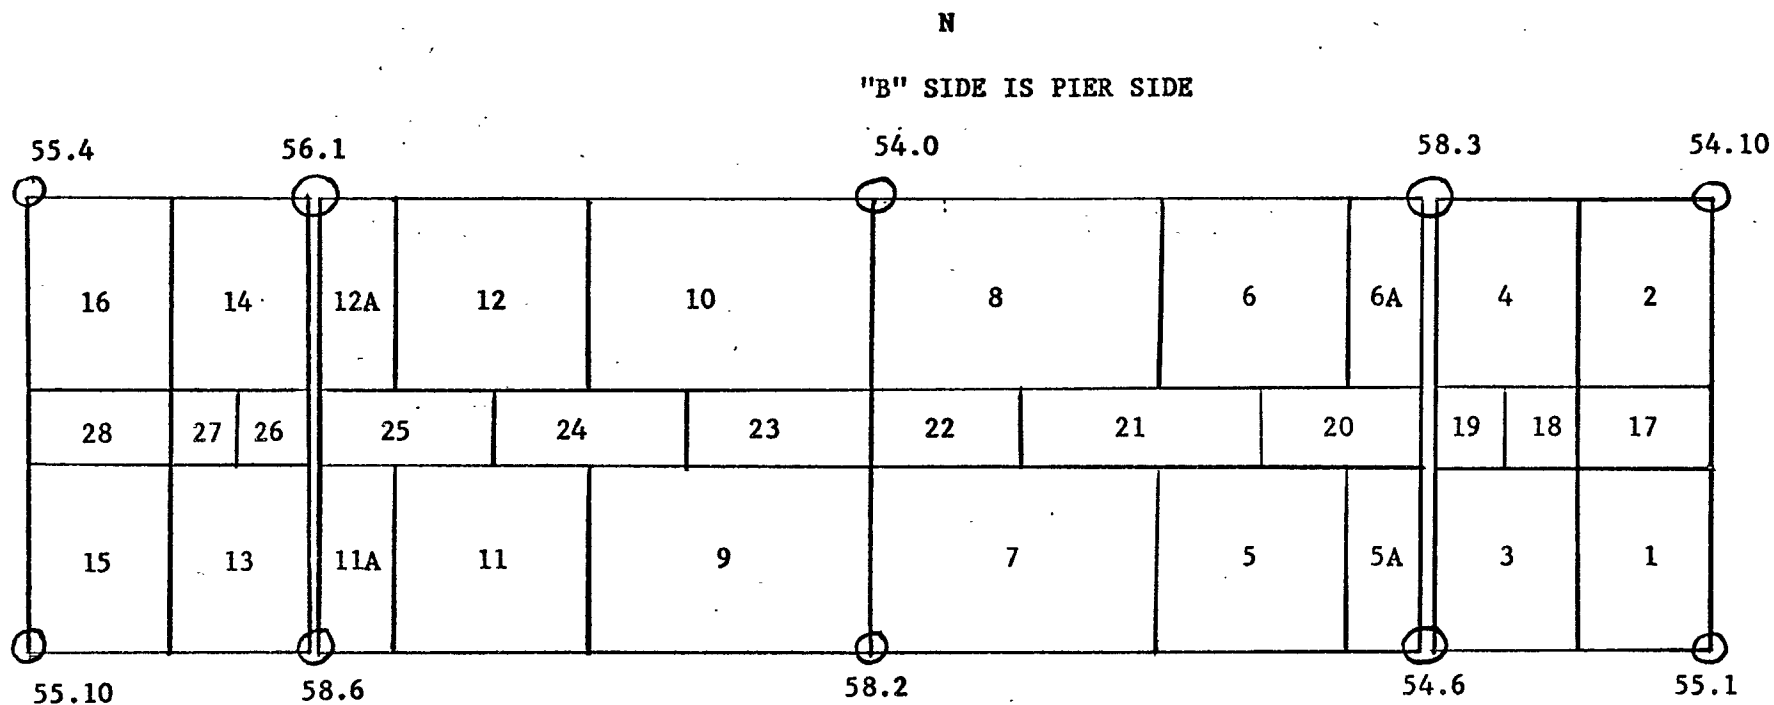
River stage = 6.1 above zero gauge
U. S. Engr. Datum, 14 December 1962

9. Dry Dock Basin Soundings taken at the dry dock basin in 14 Dec 1962 with the river stage at +6.1 elevation, are as follows: (date)
